# Durability Project Mineral wool

## Report on findings E3.3-2016/01

**Subject:** Durability Project Mineral wool

**Report No.:** E3.3-2016/01

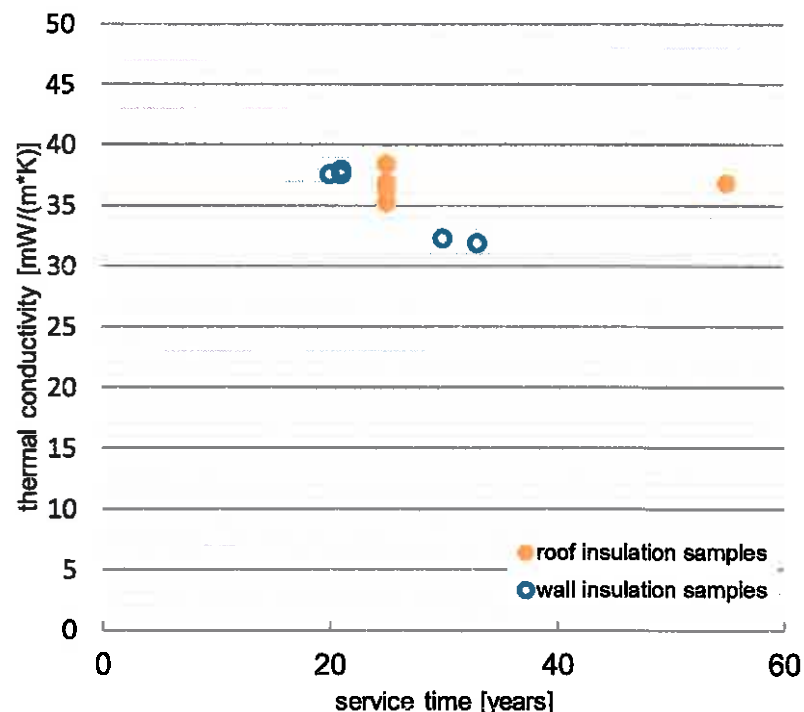
Figure 2 shows the results of thermal conductivity as a function of service time for each sampling point tested. It shows no evidence of a higher conductivity of older samples and thereby neither indicating a product-specific change of conductivity for older products nor a rise of thermal conductivity due to ageing mechanisms.

Figure 1: thermal conductivity for all samples tested as a function of service time

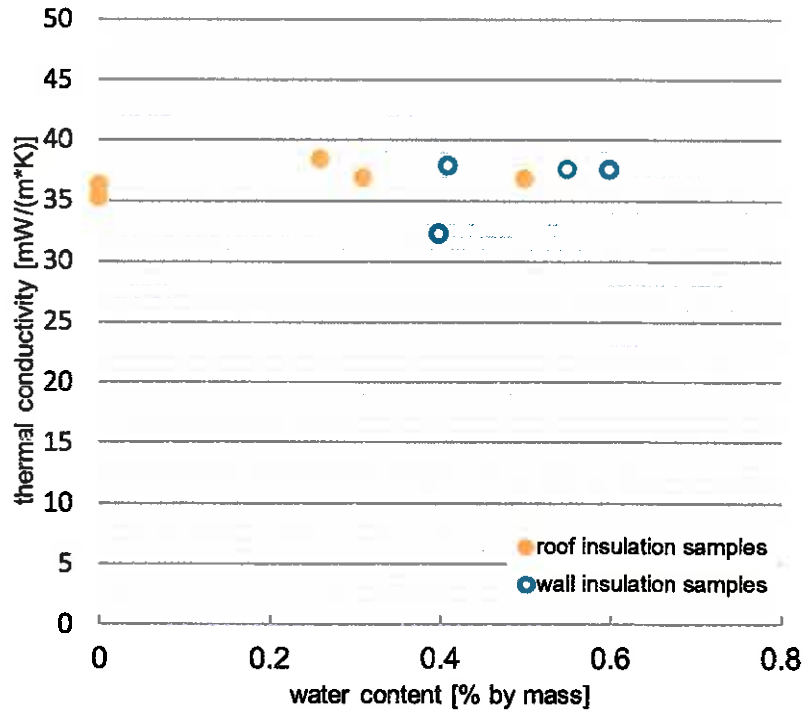
Figure 2 shows all measured thermal conductivity values for both applications as a function of the samples' water content. The differences in measured moisture content did not show significant impact on thermal conductivity. This demonstrates that both the water content in the constructions was inconsequential for the thermal properties and the sensitivity of the thermal performance of mineral wool to moisture in the expectable range for faultless constructions is very low.

**Figure 2: thermal conductivity vs. water content by mass of the thermal conductivity samples at the time of testing.**

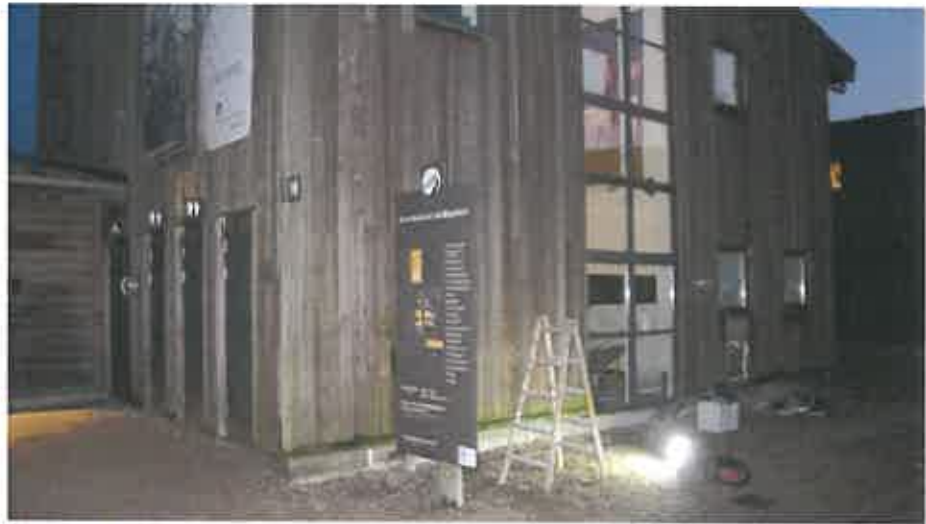
Photo no. 1

The cavity wall was intact at the start of the sampling (Picture no. 1).

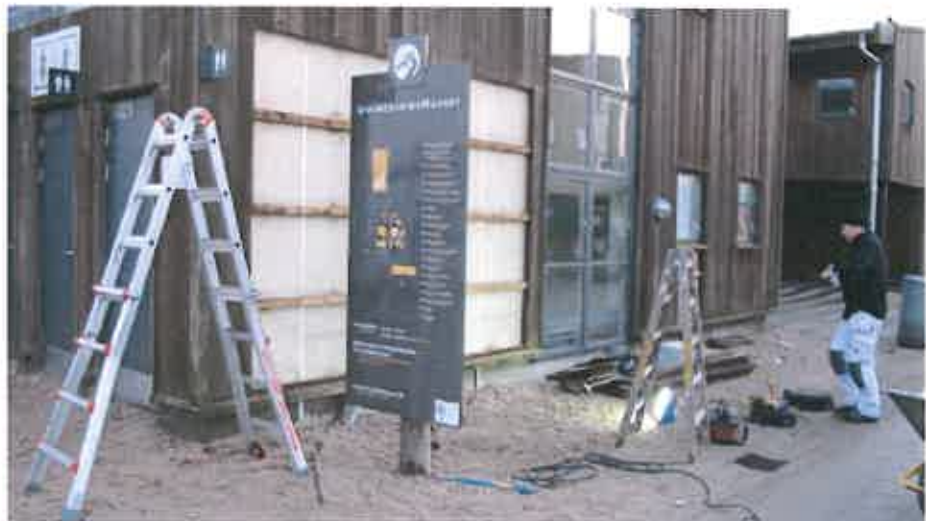
Photo no 2

Firstly, the 2 craftsmen removed part of the cladding (cedar wood). Behind the cladding was found gypsum plaster boards used as wind shield (picture no. 2).

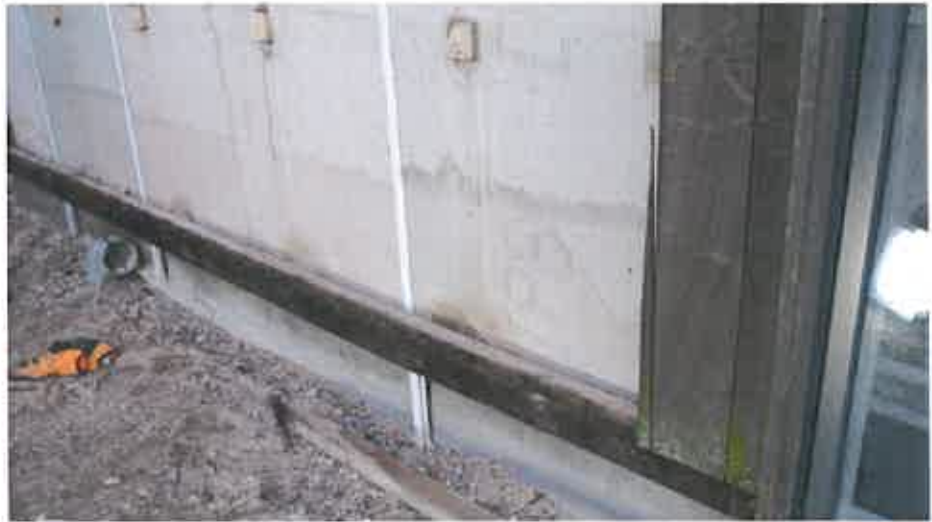
Photo no. 3

The lower part of the gypsum plaster board had a darker colour than the upper parts. A possible explanation of this could be the flooding in December 2013 (Picture no. 3).

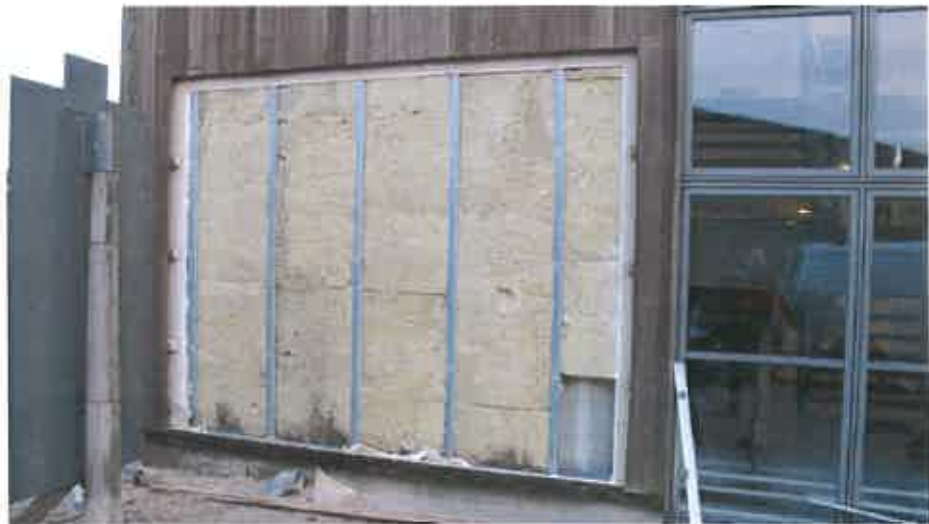
Photo no. 4

Secondly, the gypsum plaster boards were removed to make the insulation material visible (picture no. 4).

The slabs were marked with a number, 1 through 11 omitting no. 4. (Picture no. 4).

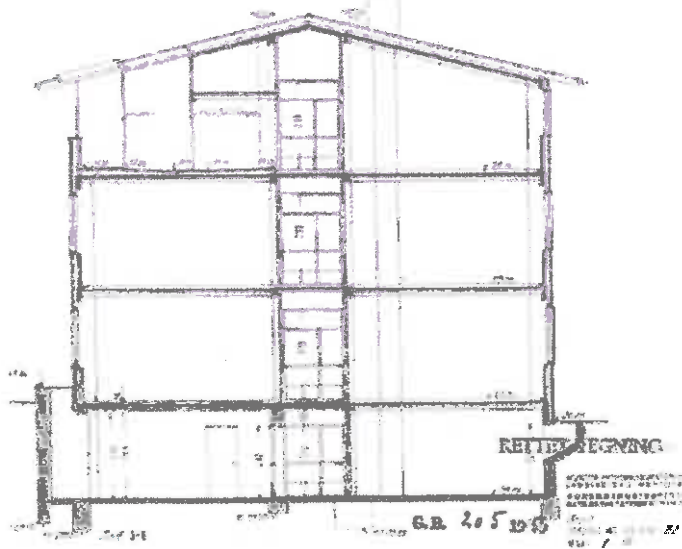
Part of the original drawing from 1956

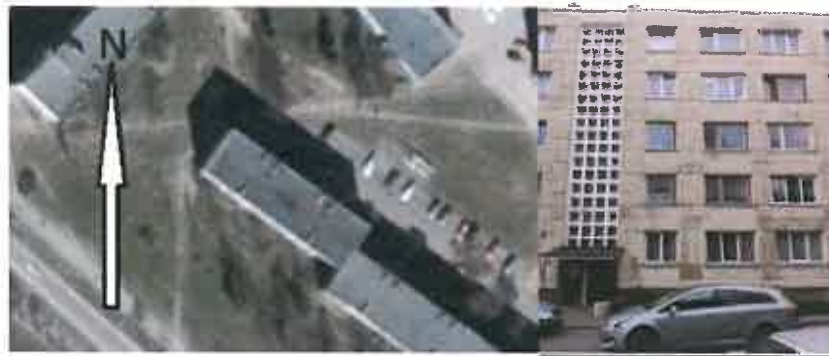
Figure 1. Place of sampling

**Place of sampling:** Facades of exploited multistoried building (Figure 1).

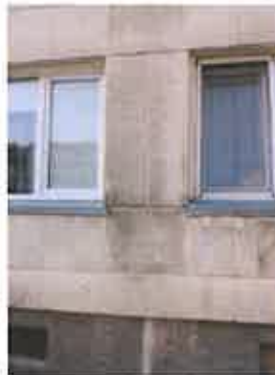
Figure 2. Place of sampling on facade

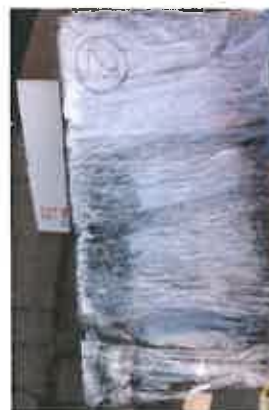
Figure 3. Specimen prepared for determination of moisture content

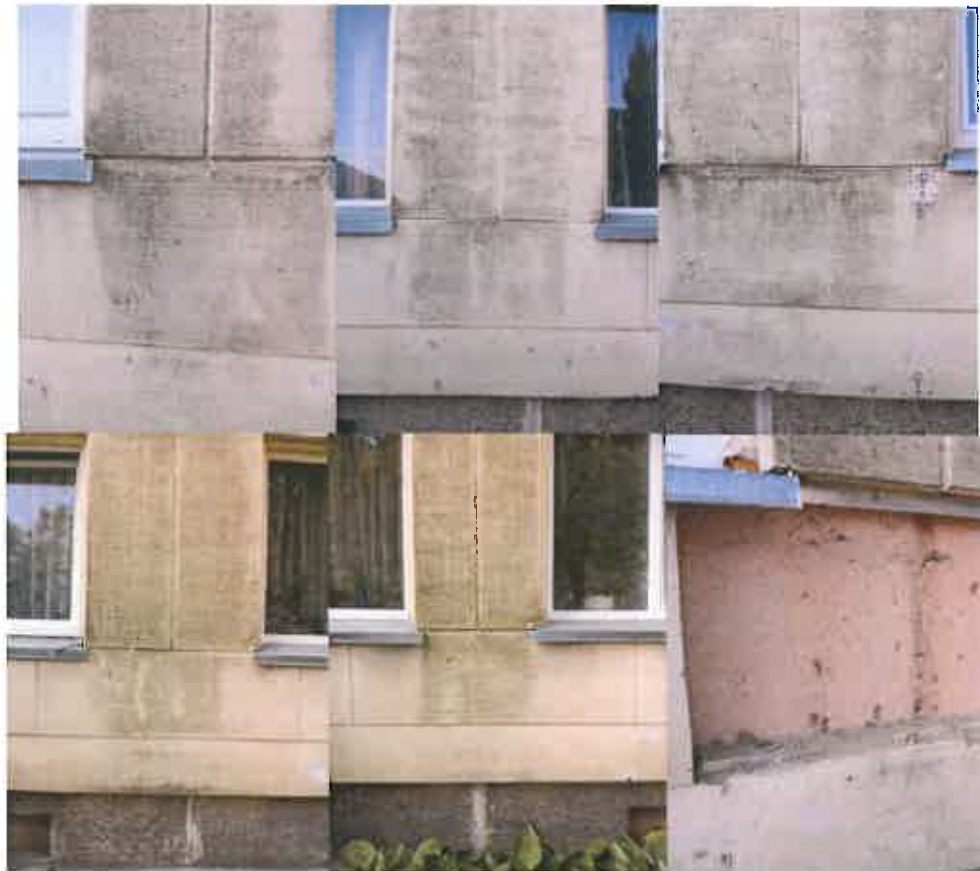
Samples were taken from the North-east orientation façade of building: No1; No2; No3; No4; No5 (Figure 4). The specimen No2 was prepared for determination of moisture content.

Figure 4. Samples were taken from the North-east orientation façade of building: No1; No2; No3;  
No4; No5

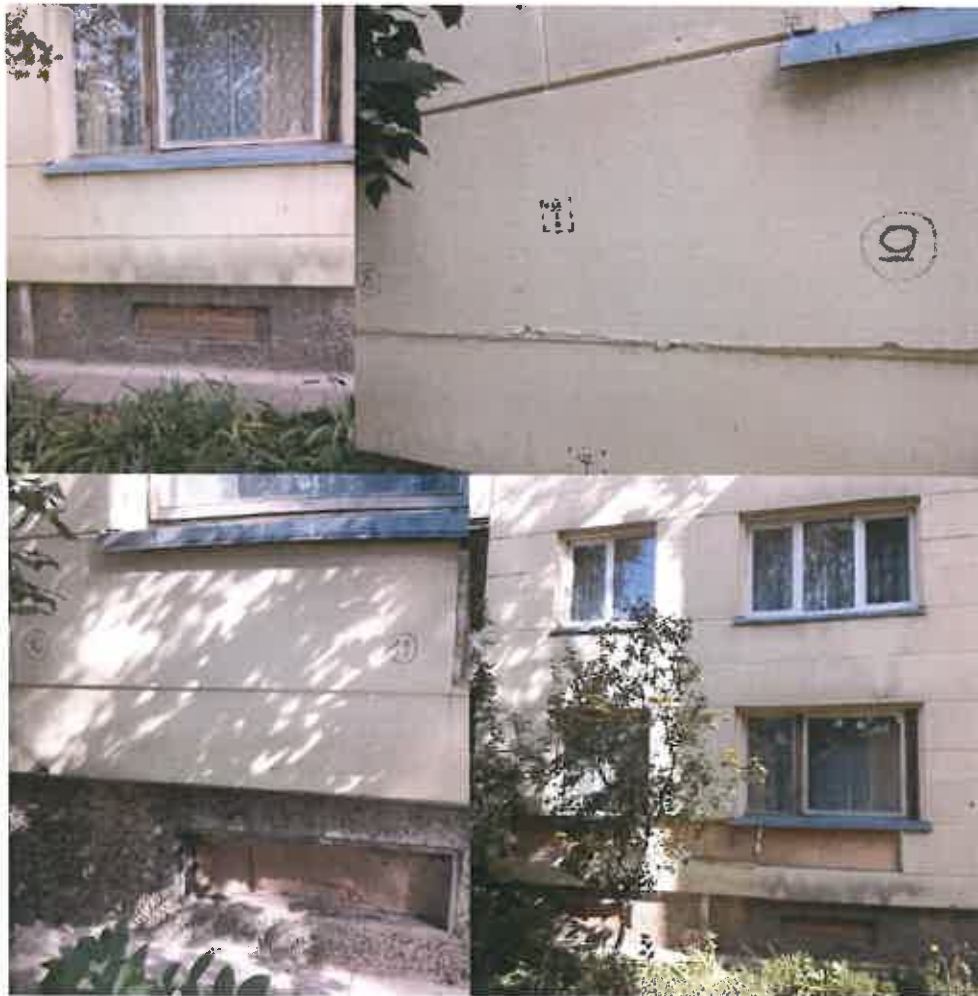
Samples were taken from the south-west orientation façade of building: No6; No7; No8; No9; No10; No11 (Figure 5). The specimen No8 was prepared for determination of moisture content.

Figure 5. Samples were taken from the south-west orientation façade of building: No6; No7; No8;  
No9; No10; No11.

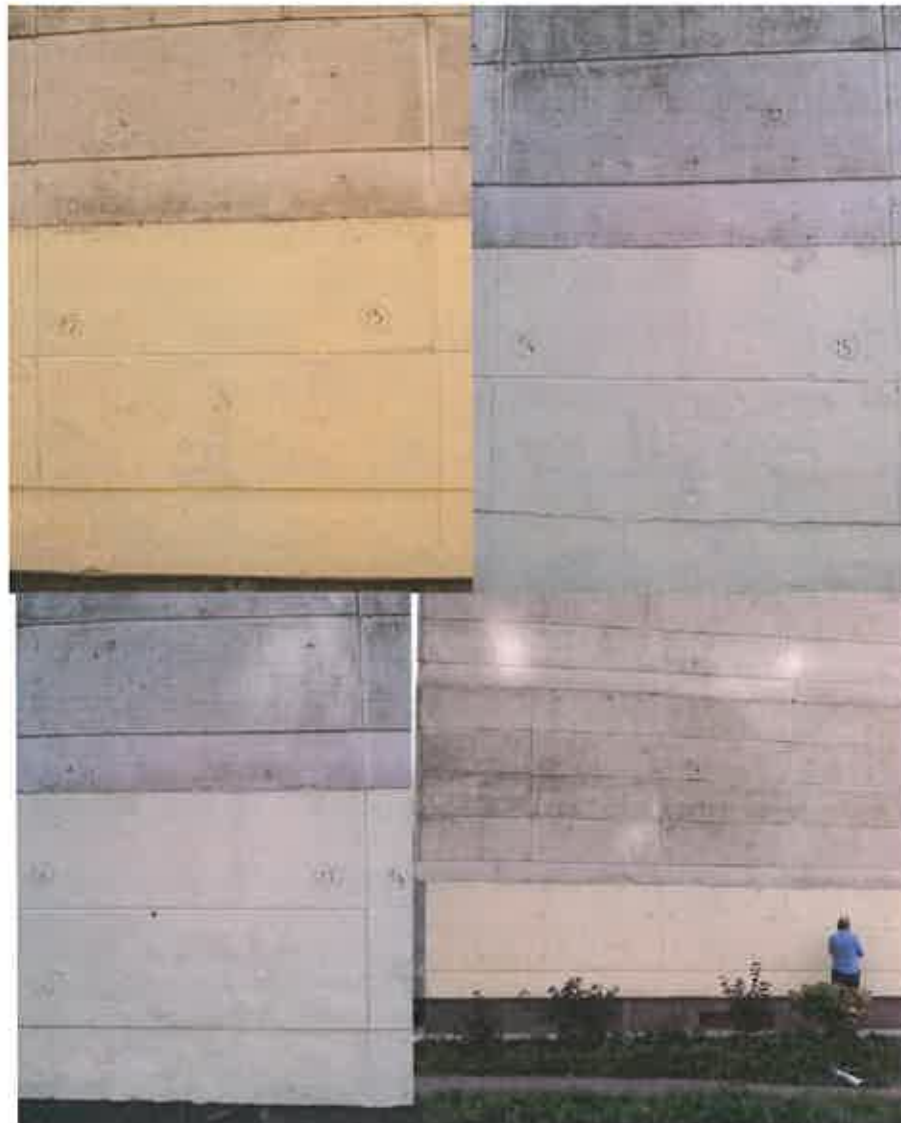
Samples were taken from the North-west orientation façade of building: No12; No13; No14; No15; No16; No17 (Figure 6). The specimen No17 was prepared for determination of moisture content.

**Figure 6. Samples were taken from the North-west orientation façade of building: No12; No13;  
No14; No15; No16; No17**

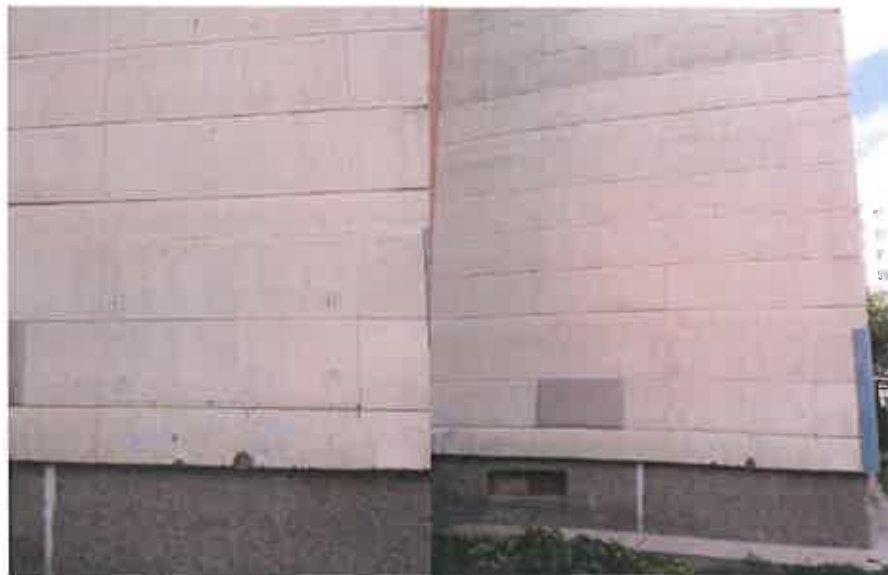
Samples were taken from the south-east orientation façade of building: No18; No19; No20; No21 (Figure 7). The specimen No18 was prepared for determination of moisture content.

Figure 7. Samples were taken from the south-east orientation façade of building: No18; No19; No20; No21

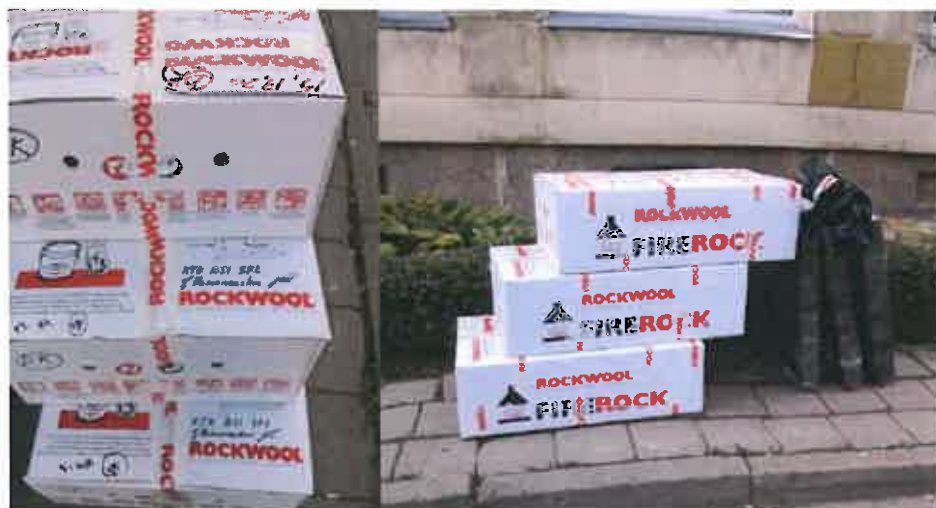
Figure 8. The samples packed into carton boxes for sending to the laboratories. The boxes signed for representative of laboratory
